PROPERTY INSPECTION REPORT

04120702-206 North Shellbark, Muncie IN

THIS INSPECTION WAS COMPLETED BY
TONY ROLLI
Indiana State License
#HI00500238

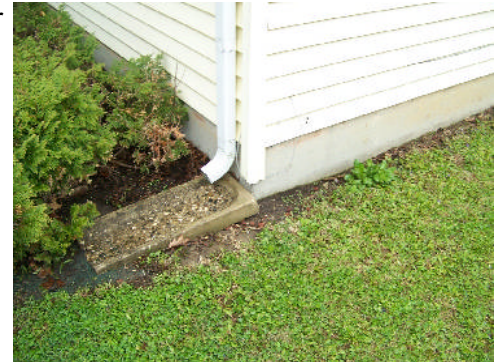
Attention Needed - The shrubs and/or bushes need to be trimmed or maintained.

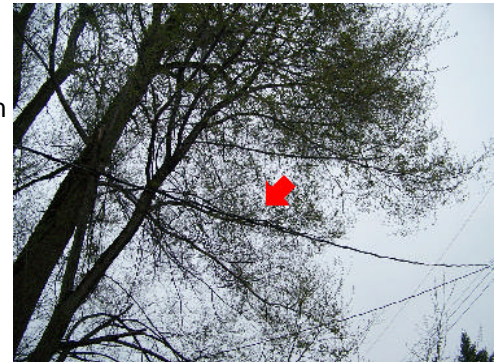
Action Necessary - At least one tree on the site needs to be removed or have portions removed. Trees that have power lines passing through them can cause power outage. Tree limbs can break off due to wind or ice. The owner may be responsible for repair expenses.

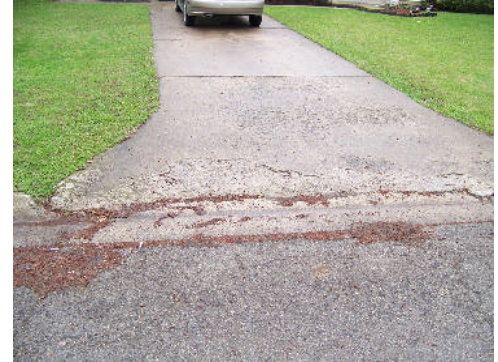
Attention Needed - The driveway needs attention and minor repair to prevent further deterioration.

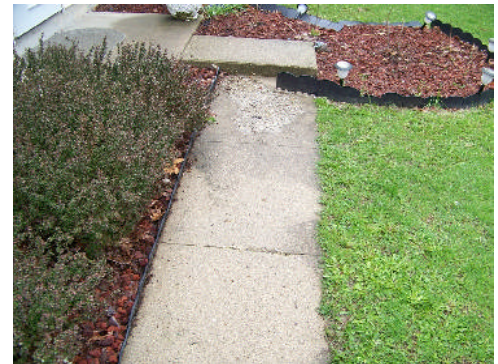
Attention Needed - The walkways need attention and minor repair to prevent further deterioration.

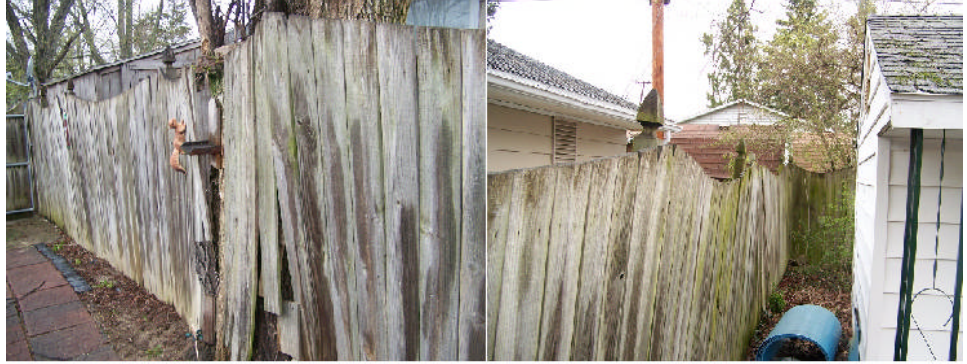
Action Needed - The fencing is not performing its intended function. Repair or replacement is suggested.

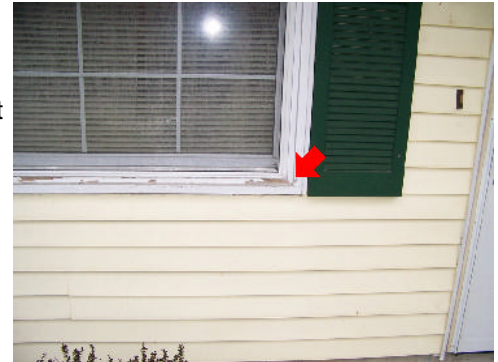
Trim Condition: **Attention Needed** - Trim needs some minor repair to prevent further deterioration. Some portion of the trim boards needs some painting to prevent further deterioration.

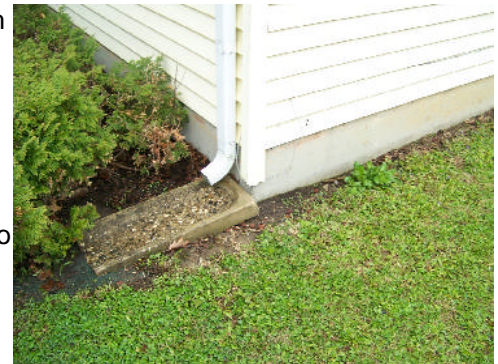
Attention Needed - The gutter system on the roof edge appears to be leaking or inadequately sloped to carry the water to the downspouts. The downspouts appear to be clear and functional. Runoff water needs to flow away from the side of the house at least 6 feet. This will allow the runoff to get far enough away to not interfere with the foundation.

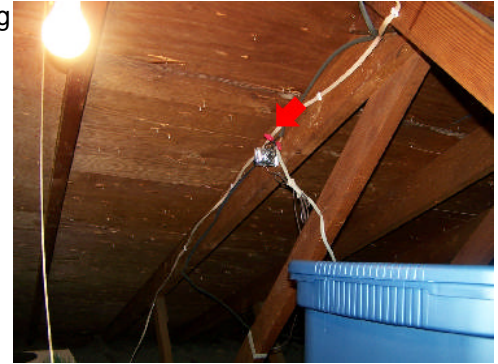
There are improper splices to the wiring in the attic, recommend that all splice be placed within a proper junction box.

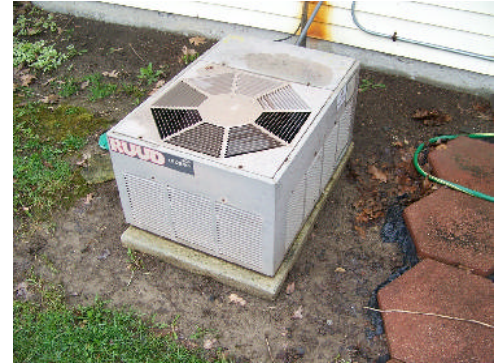
Brand - Ruud 2 Ton; Model # UACC-024JAS; Serial #3114 F2390 7014 ; This unit was manufactured about 1990. The typical service life for an AC unit is 12 - 15 years. Although this unit was operational during the inspection, the age and/or condition is such that you may need to replace it in the near future.

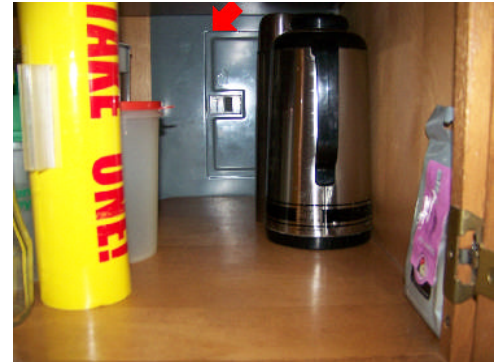
Laundry Room, The panel was completely inaccessible, due to the installation of a cabinet over the panel.

No - The electrical panel is not in a location that makes it readily accessible as required by industry standards. The power panel should be installed in a manner that is capable of being reached safely and quickly for operation, repair, or inspection without requiring those to whom ready access is requisite to climb over or remove obstacles. This is according to current safety standards.

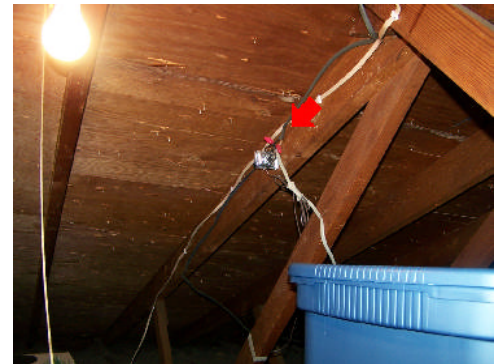
Action Necessary - Some portion of the exposed electrical wiring requires IMMEDIATE REPAIR by a qualified licensed electrician. There is at least one splice made outside a proper junction box.

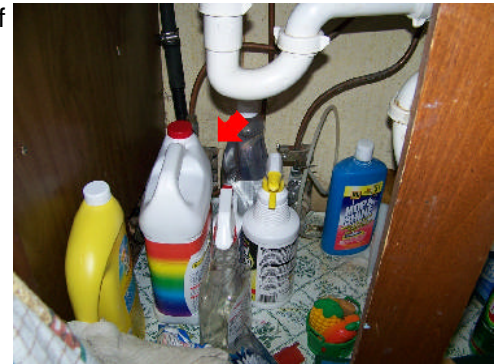
Under the kitchen cabinets, the shut off is not accessible.

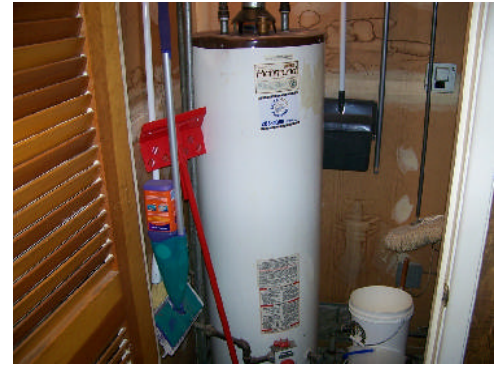
Brand - Richmond ; Model # - 82V40; Serial # -0288312751 ; Manufactured approximately, 1988. The average service life for a water heater is 10 - 12 years.

Rust Noted - Shows signs of rust and some deterioration, but is functional and not leaking.

There is rust on the underside of the tank.

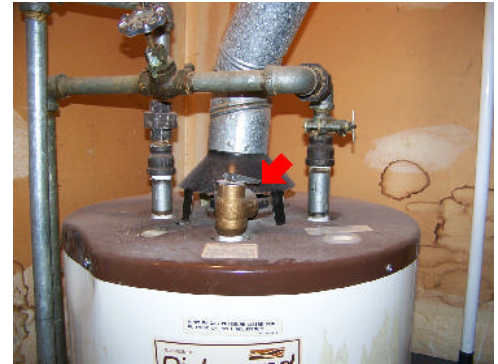
Action Necessary - There is no overflow pipe installed. For safety reasons, immediate installation is needed to help minimize possibility of serious injury.

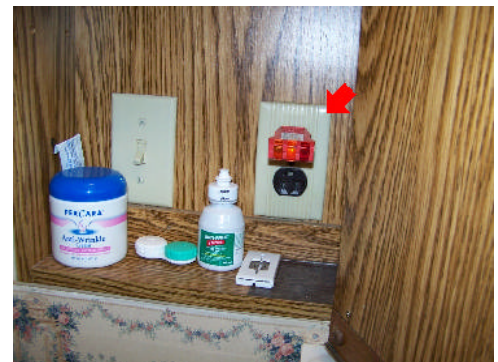
Electrical Outlets: **Action Necessary** - At least one outlet tested in this bathroom is incorrectly wired or needs to be replaced. The 3-prong outlet installed is not correctly grounded.

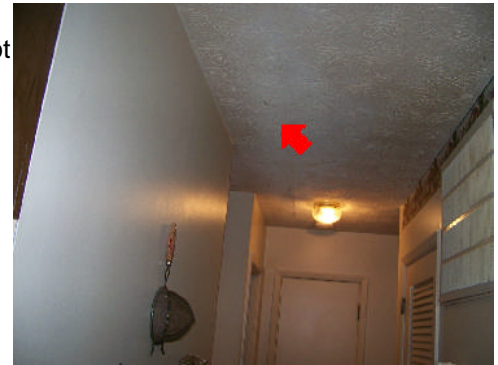
The Main Entrance Faces:	West.
Front Entrance Door:	Satisfactory - The main entry door to the structure is in functional condition.
Screen/Storm Door:	Satisfactory - There is a combination storm and screen door installed, and it appears to be functional.
Entry Floor:	Satisfactory - The entry floor material is in satisfactory condition.
Main Hallway:	Attention Needed - The main hallway ceiling needs attention. There does not appear to be a structural concern at this time. There is evidence of an unrepaired stain on the ceiling caused by a prior moisture leak.
