## PROPERTY INSPECTION REPORT

09130601-3805 West Allen Court, Muncie, IN

THIS INSPECTION WAS COMPLETED BY  
TONY ROLLI  
Indiana State License  
#HI00500238

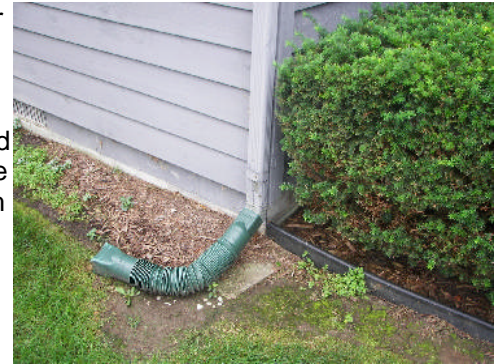
**Attention Needed** - The shrubs and/or bushes need to be trimmed or maintained. Bushes and shrubs need to be trimmed away from the structure at least 2 inches. This space is needed to prevent direct access to the structure by insects and to keep the bushes from damaging the siding.

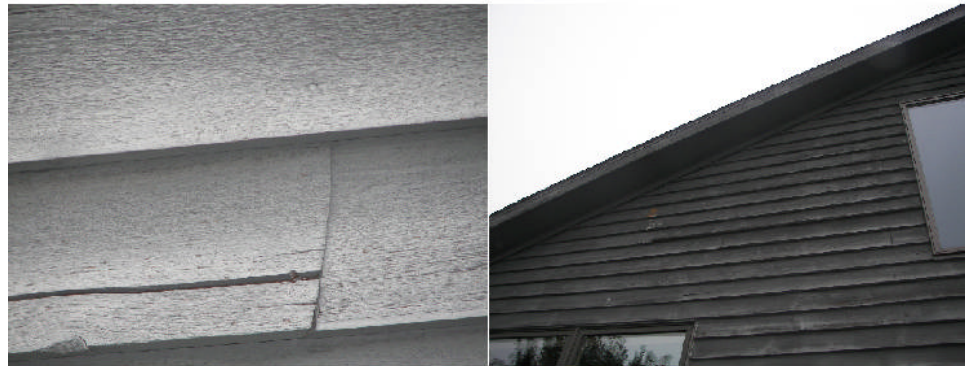
Horizontal beveled siding. Cupping-Warping-Delaminating of the siding are all signs of deterioration in the siding material. Action is needed to correct or delay further deterioration. Attention Needed - There are some splits noted in the siding that need to be sealed to prevent deterioration and water entry. The splits may be such that some re-nailing would be needed. Some strips may need to be replaced.

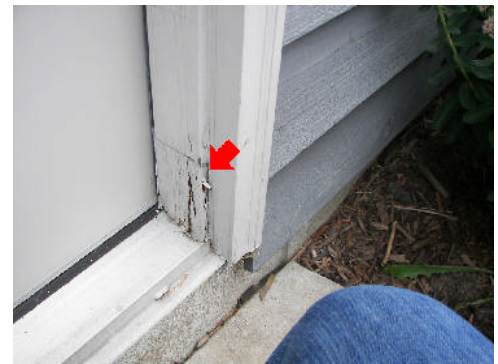
**Condition of Painted Surfaces:** **Attention Needed** - The exposed painted surfaces need some minor attention or touch-ups to make the surfaces weathertight. These repairs should be scheduled soon to prevent further deterioration.

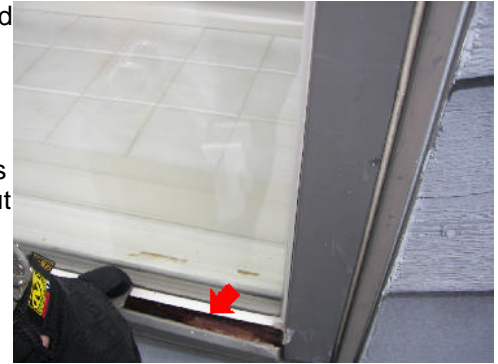
Insulation Seal - One or more insulated glass windows have lost their vacuum seal. As a result of losing this seal, condensation between the two panes creates a clouded or streaked appearance. The window still performs the task of keeping the weather out, but it has lost much efficiency. The trim work around the noted windows are showing signs of rot and deterioration, recommend repairs and or replacement. The windows over the master tub has deteriorated trim. There are several windows that have lost their seal, recommend evaluation and replacement of damaged windows.

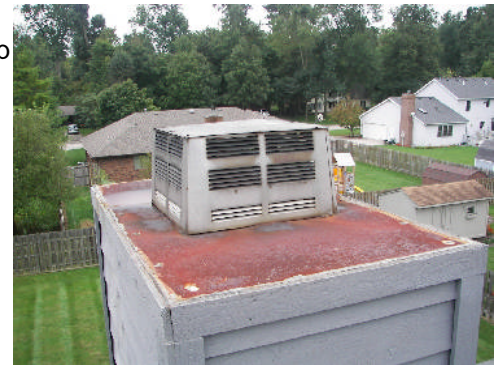
**Attention Needed** - The chimney cap is made of metal. Its function is to keep water out of the stack. A condition exists that is causing the cap to not perform as intended. Repairs are necessary to keep water out. The metal cap is sunken, allowing water to pond on the cap. This may allow water to leak down the side of the metal flue.

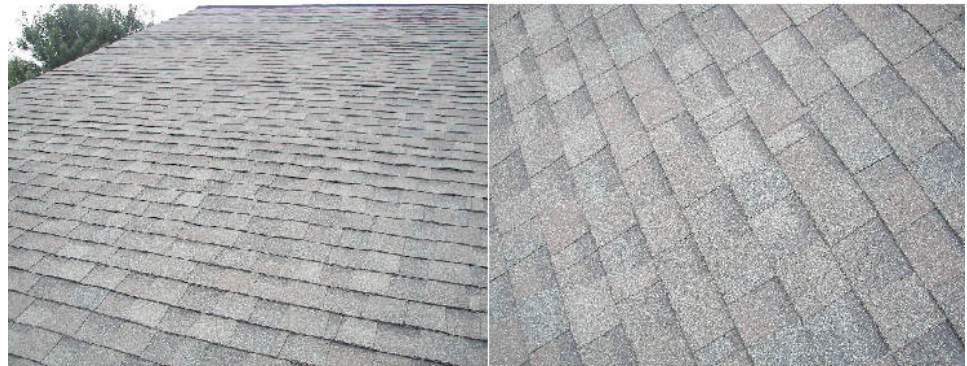
Good - The roof covering material is either new or near new. Due to the roofing being the second layer and a different type of shingle there are places where the installation was "short shingled" meaning there is not the recommended amount of shingle showing.

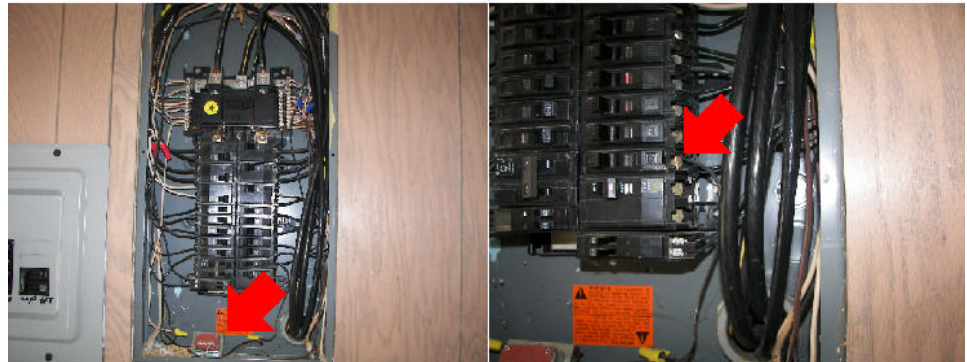
**Action Necessary** - Electrical circuitry wiring in the power panel shows some condition that calls for immediate action of a qualified licensed electrician. There are two wires to a breaker or fuse. These need to be separated, each having its own breaker or fuse. Low voltage transformer is located within the panel, recommend removal by a qualified contractor.

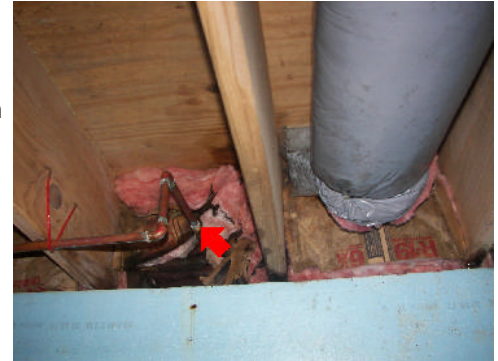
**Action Necessary** - There is a leak in the supply system. Services of a qualified licensed plumber may be required. There appears to be a leak in the south exterior bibb line.

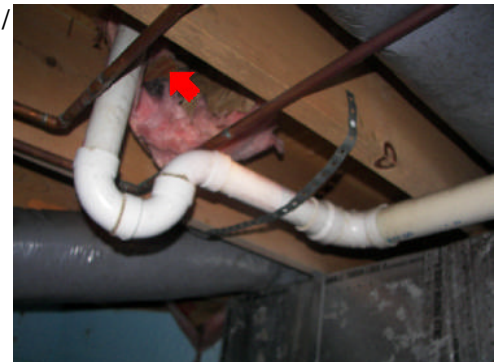
There is evidence of a leak in the drain/waste piping system. Services of a qualified licensed plumber may be needed. There appears to be leakage under the master bath shower.

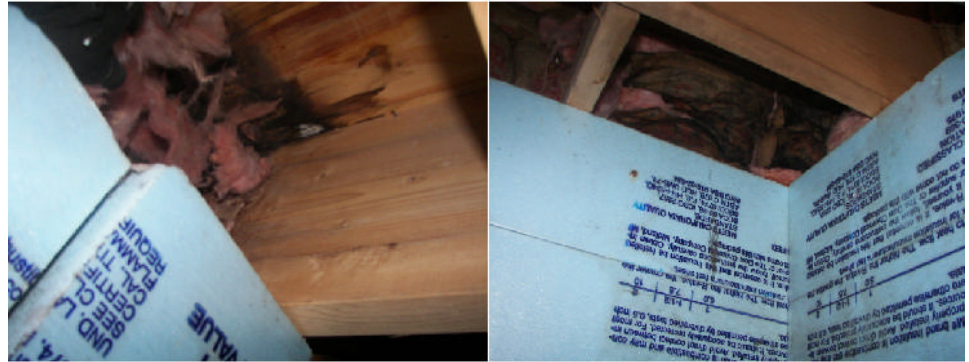
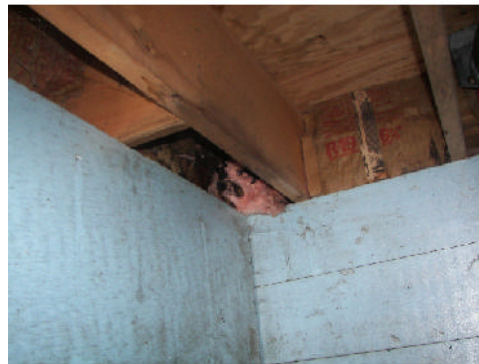
Most all of the sill plates were visible. There are signs of prior moisture issues with the band board along the southeast coner and in the north west corn of the home, black fungus was visible. Recommend treatment and evaluation to determine cause.

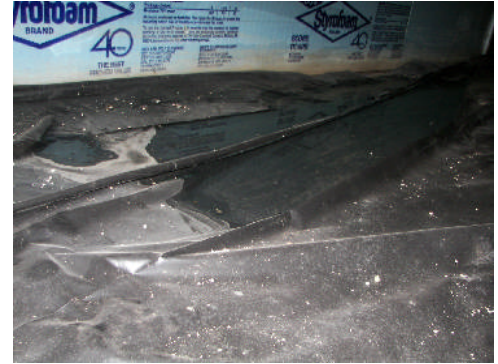
There is evidence of water entry or damage in the crawl space level.
