PROPERTY INSPECTION REPORT

04120702-206 North Shellbark, Muncie IN

THIS INSPECTION WAS COMPLETED BY
TONY ROLLI
Indiana State License
#HI00500238

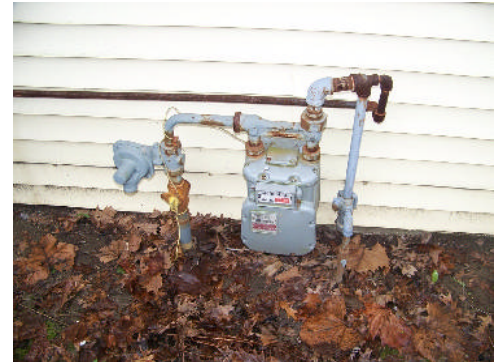
**Location of
Meter:**

Left side of the house.

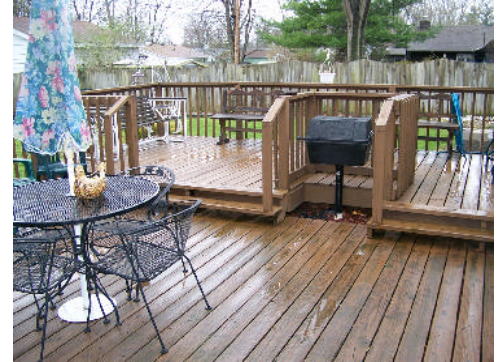
There is a Wood Framed:

Wood deck.

Satisfactory - The wood materials are in satisfactory condition.

The deck support posts are set in soil. The inspector was unable to determine the depth to which the posts are set and if the posts are set below the frost line.

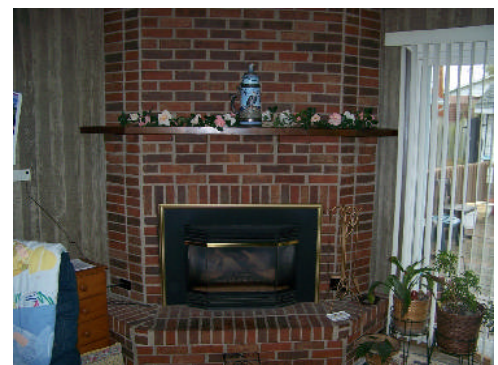
Location of Fireplace:

Family.

Type of Fireplace:	Direct Vent.
Fireplace Fuel:	Gas - The fireplace is designed to use gas fuel only.
Firebox Condition:	Satisfactory - The firebox appears to be sound and useable in its current condition.
Flue Condition From Roof:	Satisfactory - The fireplace flue, as viewed from the roof, appears to be in satisfactory condition.
Exterior Stack Material:	The exterior fireplace stack material is made of metal.
Exterior Stack Condition:	Satisfactory - The exterior stack is in satisfactory condition.
Flue Lined:	Yes - The fireplace flue appears to be lined with metal.
Chimney Cap or Crown:	Yes - There is a chimney cap.
Rain Hat :	Yes - There is a metal rain hat installed. It will help keep rain from entering the flue.
Chimney Height and Clearance:	Yes - The chimney installation appears to meet clearance requirements.
Source of Combustion Air:	Outside air is used for combustion. This is the most efficient system.

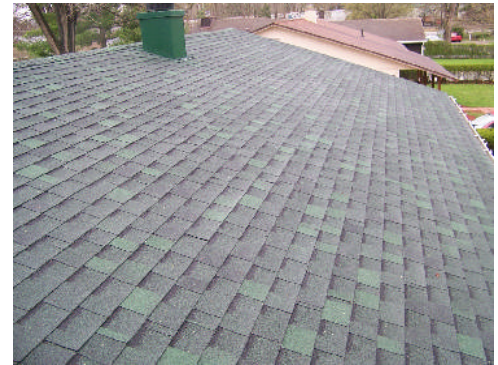
The roof covering on the main structure appears to be the first covering.

Good - The roof covering material is either new or near new, and it appears to be installed correctly.

The roof appears to be new and in good repair.

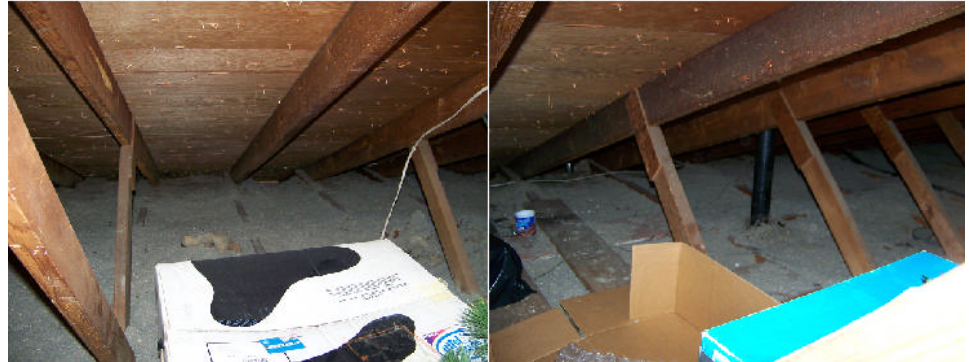
Attic cavity was inspected by entering the area.

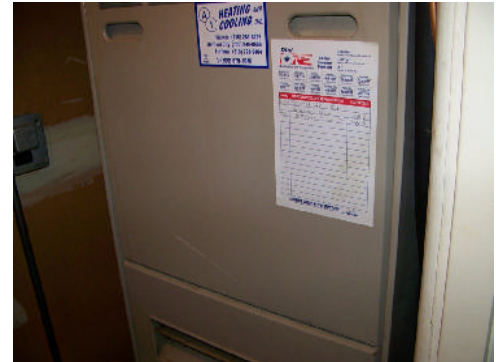
Heating System Location:

Utility Room.

A forced air furnace is installed as the primary source of heat.

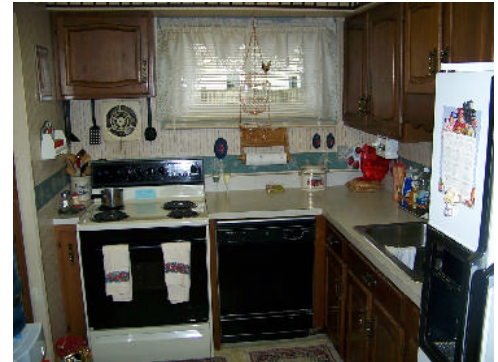
Kitchen

Location: Main level rear of house.

Windows: Satisfactory - The windows and associated hardware in this kitchen are satisfactory.

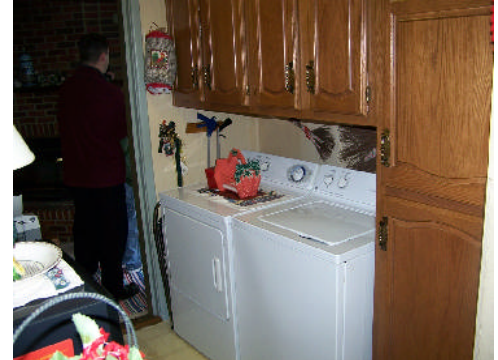
LAUNDRY

Location: Kitchen.

Walls: Satisfactory - The walls in the laundry room appear to be satisfactory.

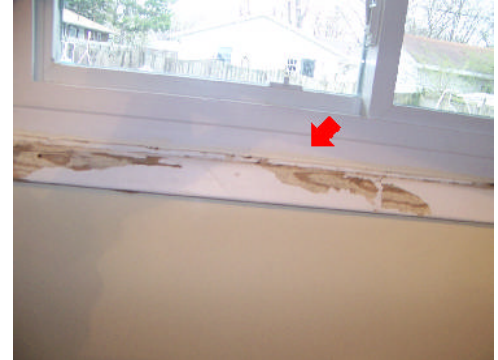
Bathroom No. 1:

Location: Hallway.
Entry Door: Satisfactory - The entry door to the bathroom is as expected, and it is functional.
Walls: Satisfactory - The walls in this bathroom are satisfactory.
Windows: **Attention Needed** - The trim is in need of painting and.

Electrical Outlets: **Action Necessary** - At least one outlet tested in this bathroom is incorrectly wired or needs to be replaced. The 3-prong outlet installed is not correctly grounded.

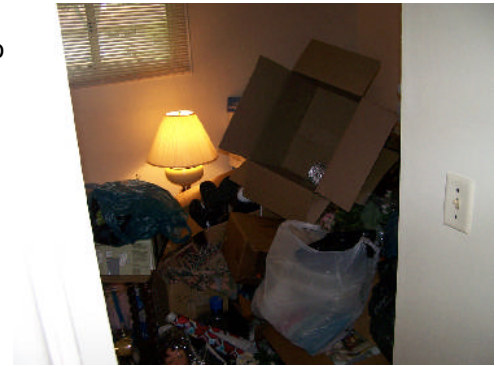
Bedroom 1:

Location: Northwest.
Entry Door: Satisfactory - The entry door to this bedroom is as expected, and it is functional.
Comment: The room was completely full of personal items, there was no access to the windows, walls, closet, and or outlets.
