## PROPERTY INSPECTION REPORT

09130601-3805 West Allen Court, Muncie, IN

THIS INSPECTION WAS COMPLETED BY  
TONY ROLLI  
Indiana State License  
#HI00500238

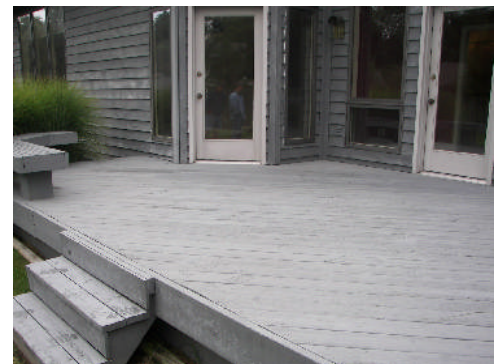
Wood deck.

Satisfactory - The wood materials are in satisfactory condition.

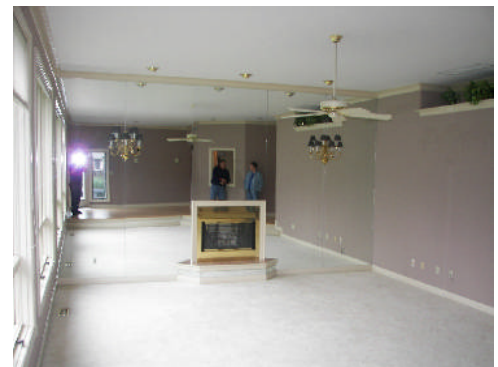
Living Room.

Metal Firebox - There is a masonry fireplace installed with a metal formed firebox.

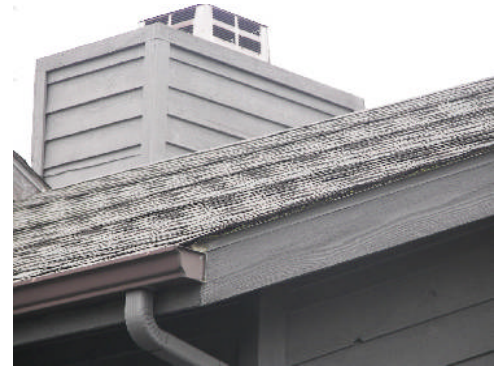
The exterior fireplace chase is wood framed and enclosed with siding material similar to the structural siding.

Satisfactory - The exterior stack is in satisfactory condition.

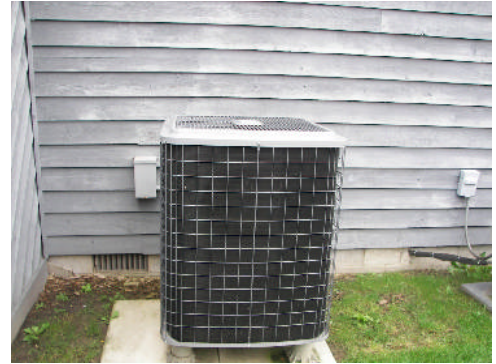
Brand - ComfortMaker 4 Ton; Model #CHP048AKC1; Serial # E034506947; This unit was manufactured about 2003. The typical service life for an AC unit is 12 - 15 years.

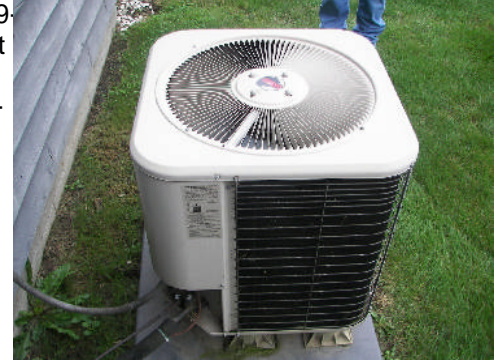
Brand - Lennox 1.5 Ton; Model # HP29-018-1P; Serial #5801J32485 ; This unit was manufactured about 2001 . The typical service life for an AC unit is 12 - 15 years.

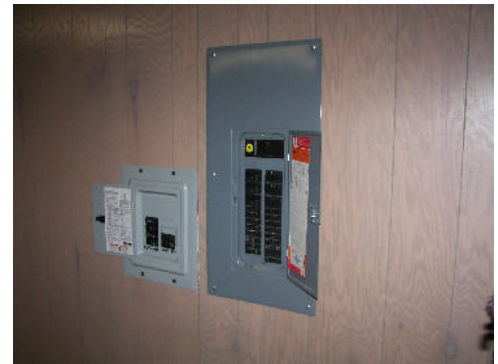
**Main Power  
Distribution Panel  
Location:** Garage.

**Main Power Panel  
Size:** 200 amp - The ampacity of the main power panel appears to be more than adequate for the structure as presently used with room for expansion.

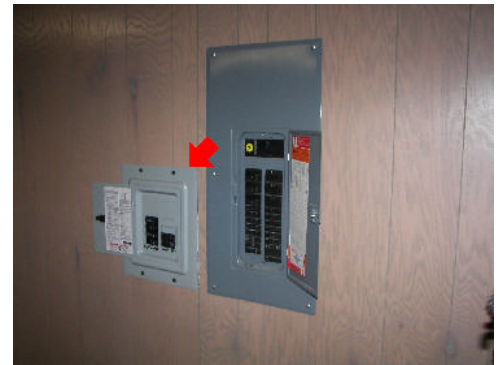
Garage.

100 amp - The ampacity of the sub panel appears to be within the normal parameters for the structure's age. However, a load analysis is recommended if you anticipate adding more circuits or load to the system.

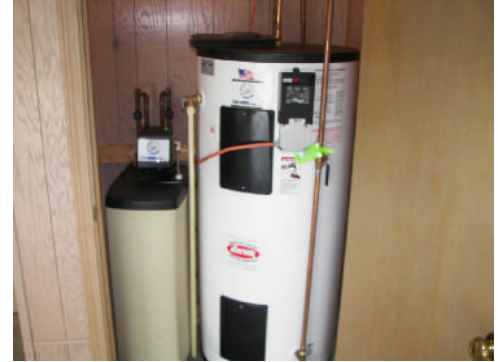
**Location:** Garage.

Brand - Vaughn; Model # -S80W3838LI ; Serial # -049761551 ; Manufactured approximately,10/2005. The average service life for a water heater is 10 - 12 years.

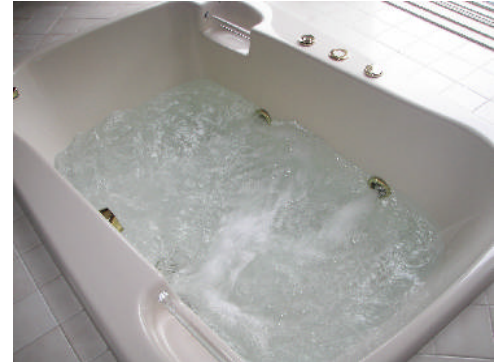
There is a spa tub installed. The tub was filled with water and the jets activated to observe for proper action. The tub appeared to function properly.
